# THE BRISTOL 70cms REPEATER GROUP

## GB3BS & GB7BS NEWSLETTER 2023

## Main Antenna Failure and its Replacement.

## Battery Booooooom!

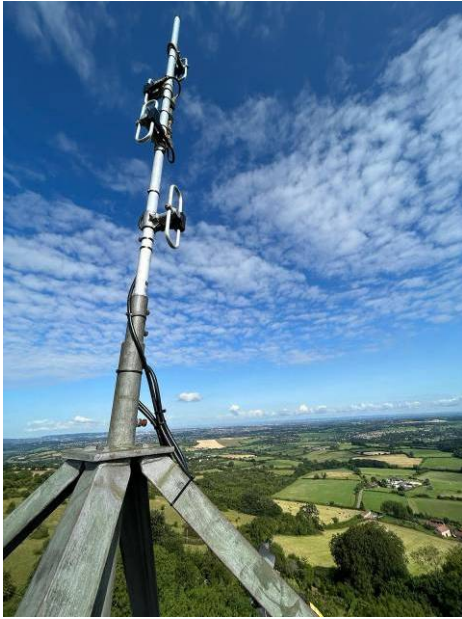
During a routine visit to site in June, I decided to check the main site Antenna as there appeared to be a very slight reduction in signal levels from both GB3BS and GB7BS as measured at my QTH.

Sweeping the antenna with a network analyzer showed that the antenna was giving a return loss of only 10dB or an SWR of around 2:1. While not excessive it was not in the range that it should be. This should be around 15 to 20dB for a return loss or a SWR better than 1.5:1.

Clearly there was an issue with the antenna and although a visual inspection showed no problems, unlike the last failure where the dipoles were hanging off due to metal corrosion, we decided that we needed to prepare for getting the antenna replaced as soon as possible as we could not tell if this fault was stable or would get worse or even suddenly fail.... taking both repeaters off the air.

The first job was to inspect the antenna, which is at the very top of the tower, to check for any obvious problems and to check the feeder leading to it. Only a short time after the riggers got up to the antenna that they reported that on inspection all of the four dipole baluns, which are sealed in plastic moldings were cracked. Clearly this was letting water in and the cause of the problem.

Once on the ground we could inspect it further. It was found that each of the baluns had indeed a crack in the same position on each plastic molding. The conclusion we came to was that water must have got into the molding via the dipole element and although not initially getting into the balun itself, caused the water to freeze and over the years it slowly expanded the crack until water could finally get into the then exposed balun housing.

Apart from the cracks in the balun moldings, the antenna was in very good condition. It was a shame that such an issue like freezing water in a molding, over time, could make the antenna fail this way. But such environments always seem to find the weak spots. This antenna lasted almost 8 years, and that is at the upper end of life expectancy for such commercial aerials, all things considered.

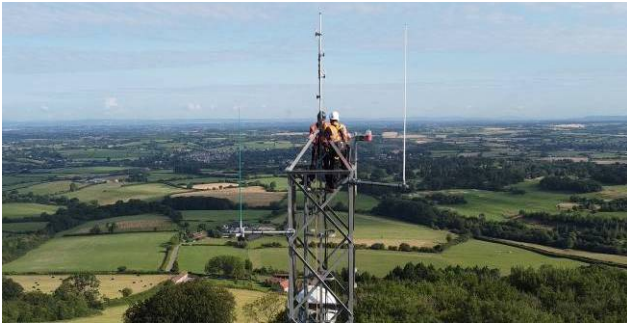
The new antenna was quickly hoisted aloft and secured on the tower. The co-ax connector on the main feeder was checked and then connected to the new antenna. The riggers then climbed down a about 10 feet away from the antenna while I carried out another sweep and finally a final SWR check. Everything looked good, with a return loss of 22dB (<math><1.5:1</math>), I was more than happy with that.

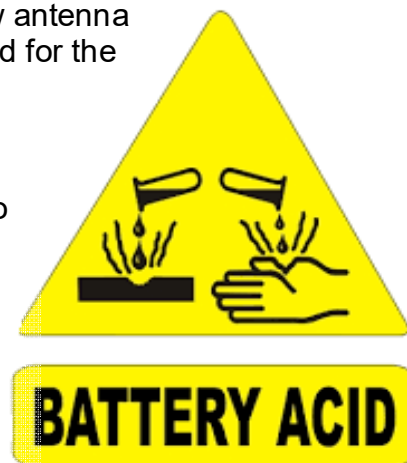
On arrival, and opening the main site doors, we were greeted by a VERY pungent acidic smell. My eyes were immediately drawn to the pair of heavy duty batteries on the floor next to the generator, used to start the generator.

On initial inspection, I could not understand why all the tops of the cells were missing their screw down filler and gas vent caps. These were found scattered all over the room along with large splashes of what turned out to be battery acid running down the walls, or rather, had been as it was now dry.

My first move was to isolate the batteries from the charger and the generator itself. Once this was done we had a closer look at the batteries. These are two heavy duty 12v flooded type batteries in series to give the 24volts for cranking the generator. We soon noticed that almost all the battery acid was gone! This was down to one of the batteries

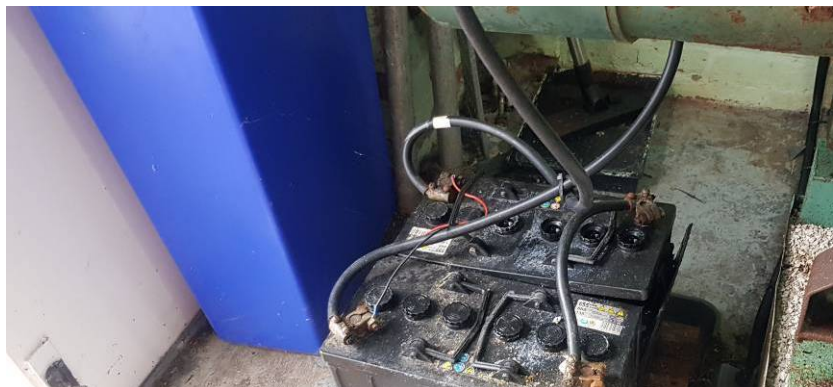
having its top almost completely blown off, and overall the whole battery had a rather large bulge.

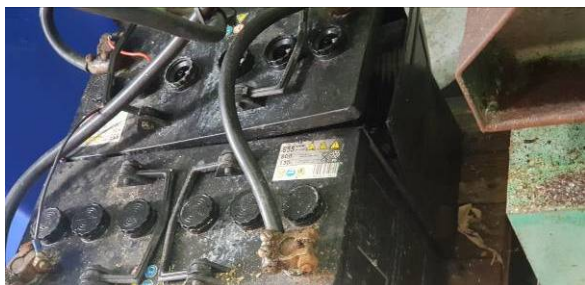
The second battery did not look too bad, on the face of it, but we soon noticed that it had obviously suffered a large explosion as the whole of one side was blown out with the plates of the battery all exposed, again, all signs of the acid were gone, it was a total wreck and it became clear that all, or most, of the acid had been sprayed all over the walls. What was left, if any, had been soaked up by a wooden stand that supported the two batteries.

So, we did a brief clean up with what we had on site. We isolated everything and decided to come back later in the week when the antenna was being swapped out and do a proper clean up and transport the wrecked batteries to the battery company for disposal, and source some new ones while we were there.

We purchased two new batteries, maintenance free ones this time, so no more topping up or acid slopping around. Having showed the old batteries to our battery supplier he noted that the probable cause of them exploding was shorted plates which then caused excessive current to heat up the battery and cause lots of gas, which then at some point, exploded! Battery age was also a factor as they were getting on a bit!

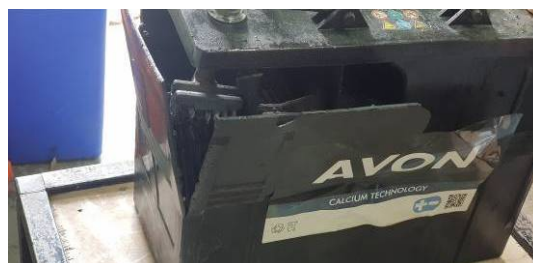
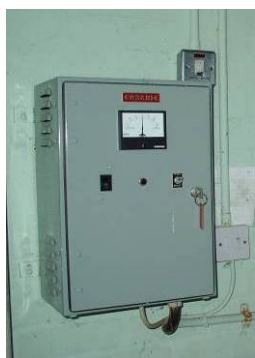
The float charger is an old wall mounted type made by Erskine and although was very old did the job of keeping the batteries topped up. Testing the charger all appeared ok, although it seemed to be down on output voltage so was definitely not capable of over charging the batteries as was our first thought. It was soon clear that we were in need of two new batteries and potentially a new float charger. Yet more expense. This was bad timing for this to happen as we were shortly to have our new antenna installed later in the week.

The next step was to check that the charger had not in some way contributed to the batteries exploding. The charger is only used for float charging and was only capable of supplying a maximum of 2 amps. Normally the float charge was only around 20mA with good batteries, but is also protected with a fuse.

We also needed a replacement float charger, so we decided to add that to the shopping list. The new charger was not much bigger than a house brick yet would fully charge, float charge, condition and monitor the batteries. We returned to site to offload the new batteries and planned to return at the weekend to install the new starter batteries and charger.

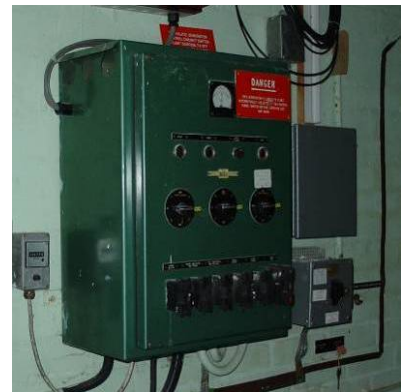
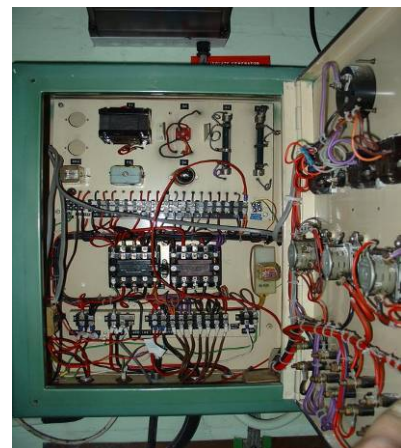
Move the clock forward to January 2023, and we were back on site and still scratching heads. There are two of contactors (Middle of the above picture) that are mechanically linked together and should stop one from engaging if the other is already switched on. Then switch over when things return to normal. This was **not** happening!

In my previous job, back, back and back again servicing contractors was a common task and I suggested a service should really be carried out. Let's face it, the control box was built at the end of the sixties, and some of the modifications were done when the site was operated by the CEBG in the '70s.

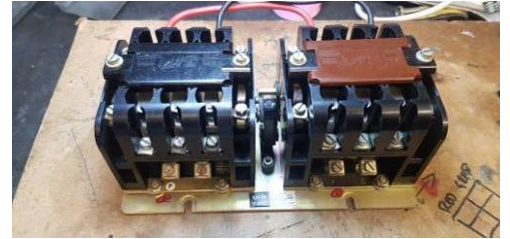
blood on one of his hands, he thrust the tray containing the contactor into my hands, and did mutter something which I missed what he said, but I assume it was a comment on how well it had gone, and how he had enjoyed his afternoon!

Back at home, I stripped the contactors down, and as expected there was a mixture of corrosion and carbon coated electrical contacts.

It took lots of paper notes and scribbles, along with megabytes of photos before Mark started the process of isolating the contactors and finally removing them from the control box. With sweat on his brow, and yes there was genuine

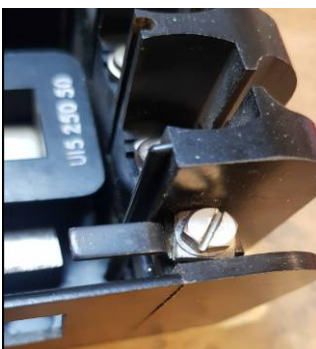
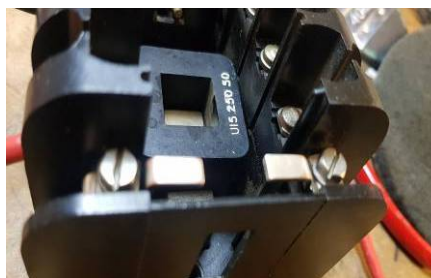
A few shots looking at a contactor, this shows it before and after cleaning.

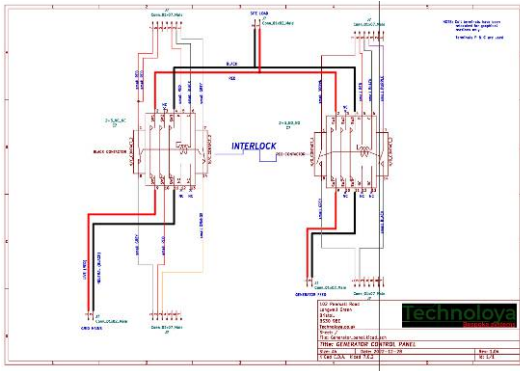
Below is a snapshot of the wire diagram I created from my paper notes and photographs of the panel. This was handy when it came to re-fitting the contactors back into the control panel. And then it was time to switch on the power! Both Mark and I were expecting a loud bang. But nothing! One contactor pulled in and that was it. We looked at each other and after a few second Mark said "Ok, that's a good sign", Cheeky I thought, followed by phew, It's working just as expected.

Of course a number of test starts were carried out and it all worked as it should. When power fails one contactor falls out (Contactor A), as it does it triggers the generator to start (The Alternator is also the starter motor). As the generator spins up to speed the AC Volts climb. Once it gets to around 220V that's enough to pull in the second contactor (Contactor B) which locks out the first contactor (A) and ensures we do not put volts back into the grid. Once mains voltage returns it forces the first contactor (A) to try and pull back in. As it does it has enough movement to force the

generator running contact to break which starts the generator spinning down. As it does the volts drop, and around the 170V mark the contactor (B) falls out and disconnects the generator fully and releases the lock. This allows the mains connected contactor (A) to fully pull in and the site is moved back onto the mains grid.
